Typical South Florida Wall

Tips and Tricks of The Trade. What is in your wall and roof and how to test it on your kitchen table? Best things in life are free. Kaz shares these tricks with designers and owners who are often unable to obtain physical characteristics of samples of brand-new materials they consider using. In many cases all you need is a cup of hot beverage.

Author: Karol Kazmierczak (Kaz)

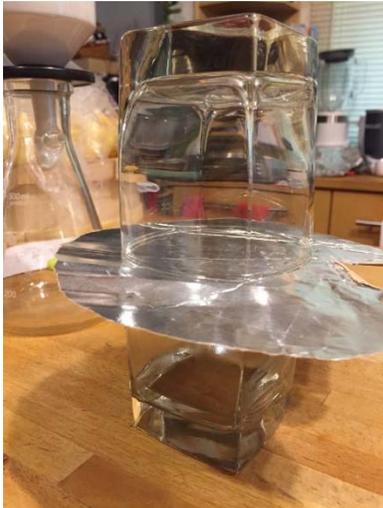
The top cup remained clear. No surprises here: the aluminum film is vapor impermeable, just like an aluminum foil used to wrap meals in our kitchen won't let any flavor to escape.

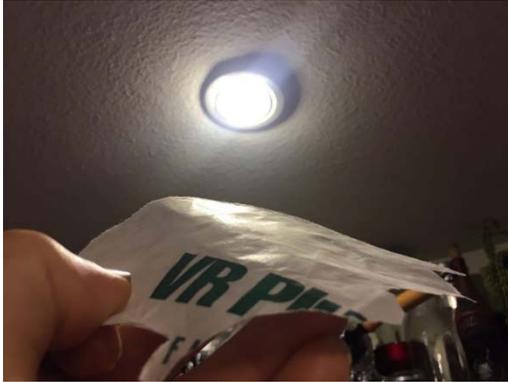
The other layer is made of paper, which is glossy on one side, as you can see here by the light reflection.

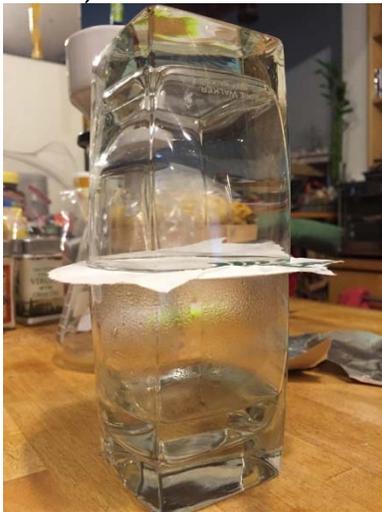
The top cup remains clear. This paper is also vapor impermeable, at least in the short term. The results so far confirm the permeability number given in its specification sheet: 0.018 perm (practically a vapor barrier).

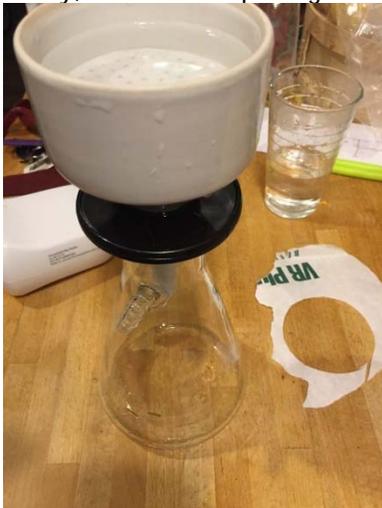
Is it water permeable? We gave it a try, by cutting a circle, placing in a filter holder. Water dripped freely, even before pulling air from the flask below.

Conclusion: It could be a moisture trap. Per the manufacturer, this material was supposed to be installed continuously, fit snugly, stapled and taped tightly, without voids and interruptions (we have yet to see it installed that way). If this material were installed that way, it would block the inward vapor drive in hot and humid climate. However, since it's typically installed improperly, we don't see moisture damage

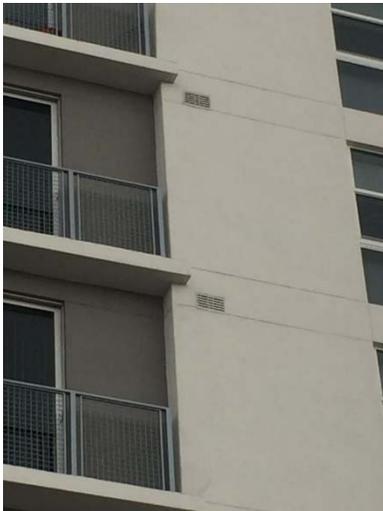
Concrete walls are also typically cracked, due to missing or inadequate differential movement compensation. *(Want to embarrass an American architect? Ask them to draw your facade tectonics: the pattern of control and movement joints on elevations.)* Cracks may differ from those visible across the street, to the invisible ones, for which one needs a bubble gun to find them. An elastomeric paints, regardless how many layers, won't bridge those cracks. You would need a dedicated, thick "condom" *(several dedicated products on the market, typically made with silicone)* which we typically recommend to our clients for remediation of such hopeless cases; their cost is significant, and it's definitely better to avoid the need for their use in the first place.

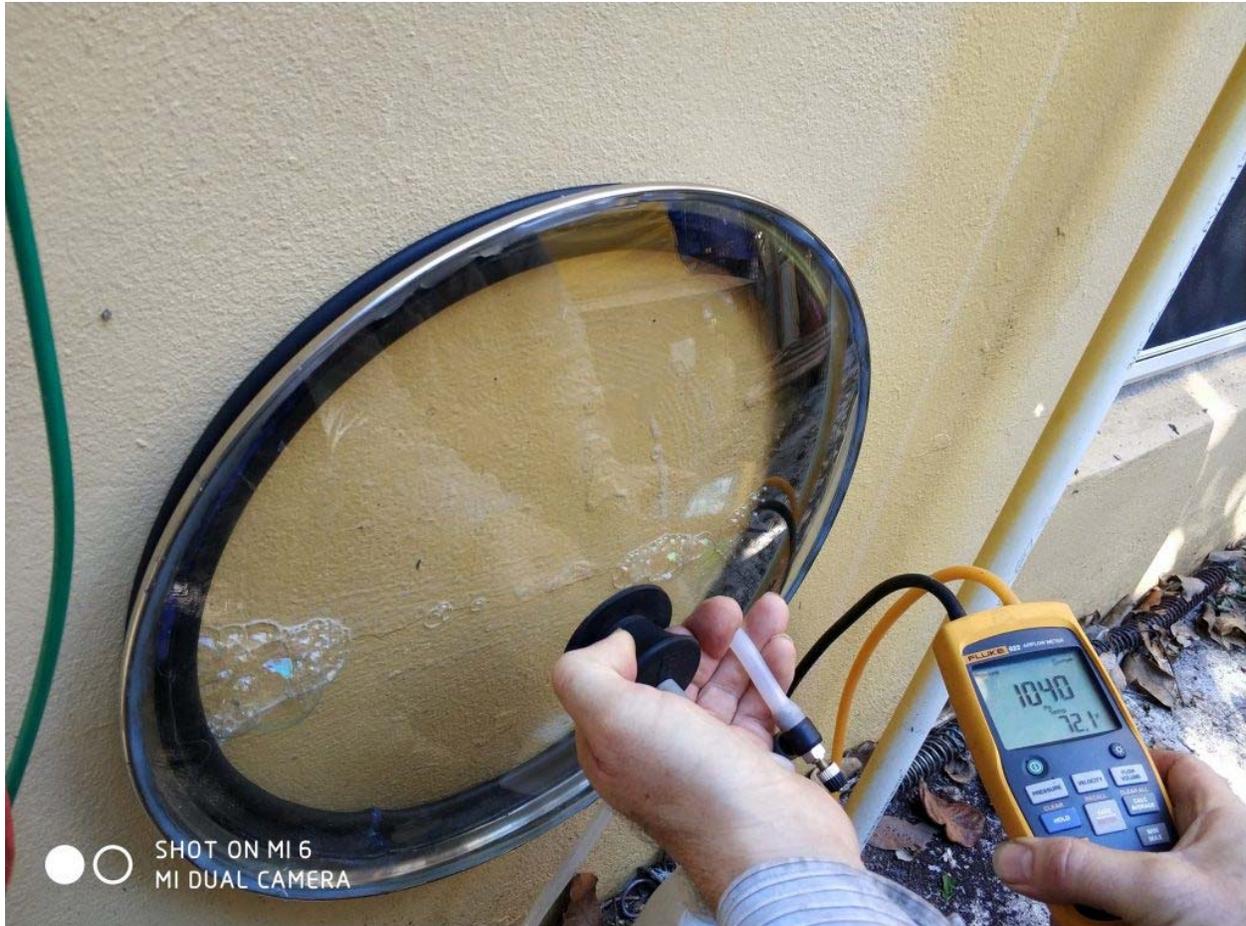
Here is [the ASTM E1186 bubble gun testing](#) of such a case, revealing air bubbling through a cracked bed joint of a CBS wall. *(It's coated with at least five layers of elastomeric latex paint.)* Many buildings are like this, and historically it didn't matter, because these are thick walls that were allowed to dry. However, circumstances changed: building interiors in the hot climate are now cooled, less vented, and interior layers of walls are impermeable more often than not. It should be no surprise that buildings also became sicker.
