## Flood Barriers

**Summary:** It's been over a decade since I posted the Flood Manual (available online at <http://karol.us/flood.html>) which was earlier developed under Flood Mitigation Best Practice Notes. General flood awareness raised since then, particularly after Hurricane Sandy inundated some highly populated areas along the East Coast, including the New York City in 2012. We were returning to re-examine the subject, particularly as it refers to prevention. I had this project in the making for so long, that I plan to start publishing its draft, as it probably going to be most effective this way, so what you have in front of you is an unfinished version, and your comments and suggestions are most welcome.

This section is devoted to deployable flood barriers that protect openings, such as doors and windows.

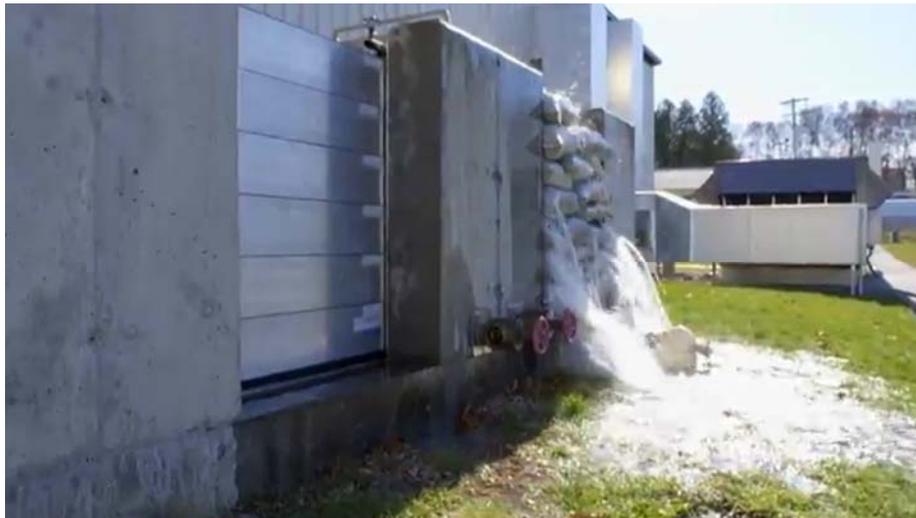
Comparison of log system and sandbags. Photo credit: FM Global. <https://www.fmapprovals.com/products-we-certify/products-we-certify/flood-mitigation-products>

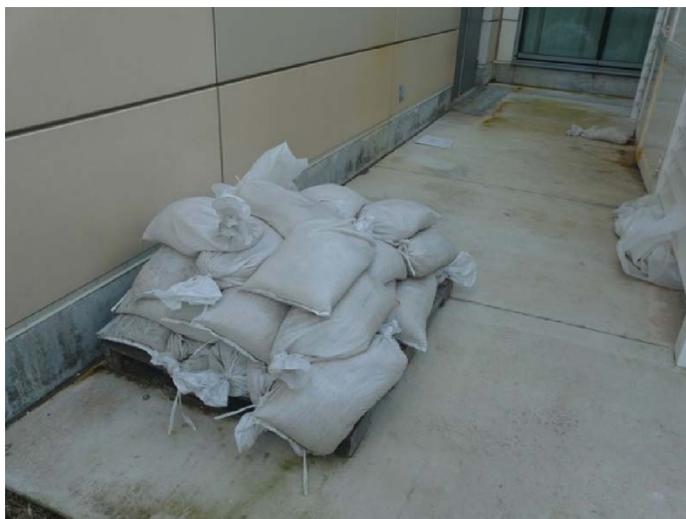
Typical pallet of sandbags stored next to entrance doors. Log system could be considered just a tighter version of the traditional pallets full of sandbags. Photo by author.

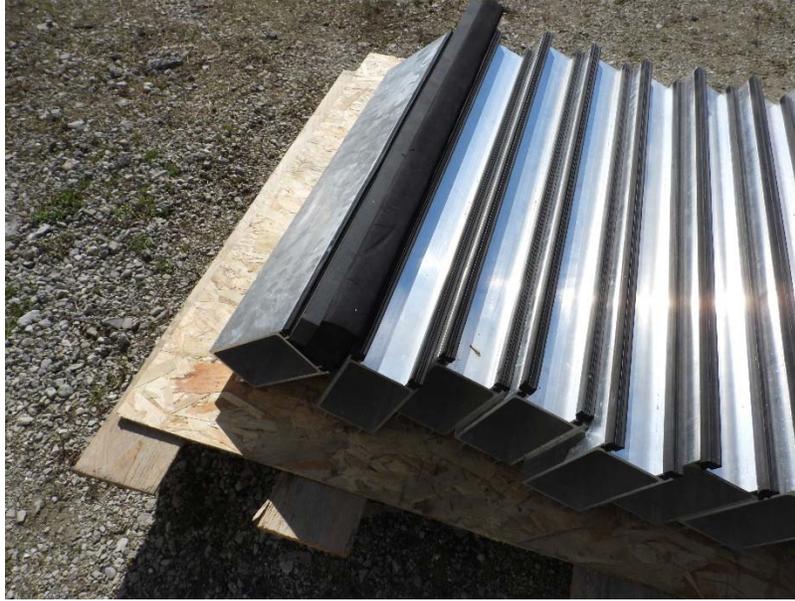
Typical logs unpacked and ready to be deployed. Photo by author.

Such systems would typically easily pass the criteria of DIN 19569-4 class 1, which allows for the maximum flow of 1 l/s/m, an approx. equivalent of 52 gal/min/ft or 3,120.14 gal/hr./ft. Translating it into buckets as in the previous example, every door would leak 1,800 buckets of water per hour. We found one manufacturer in the U.S. who claims that his flood log system meet and exceed the FM 2510 standard, which is the strictest one, and would let only half a bucket through.

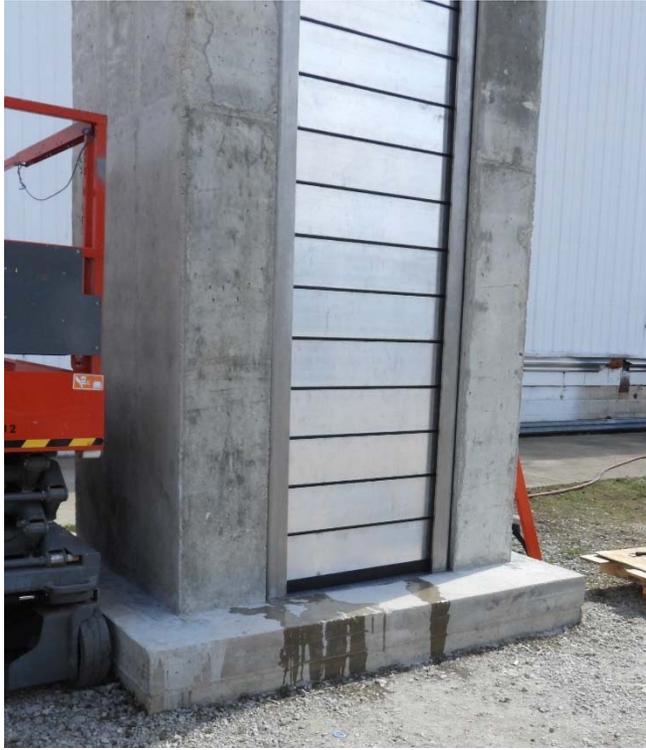
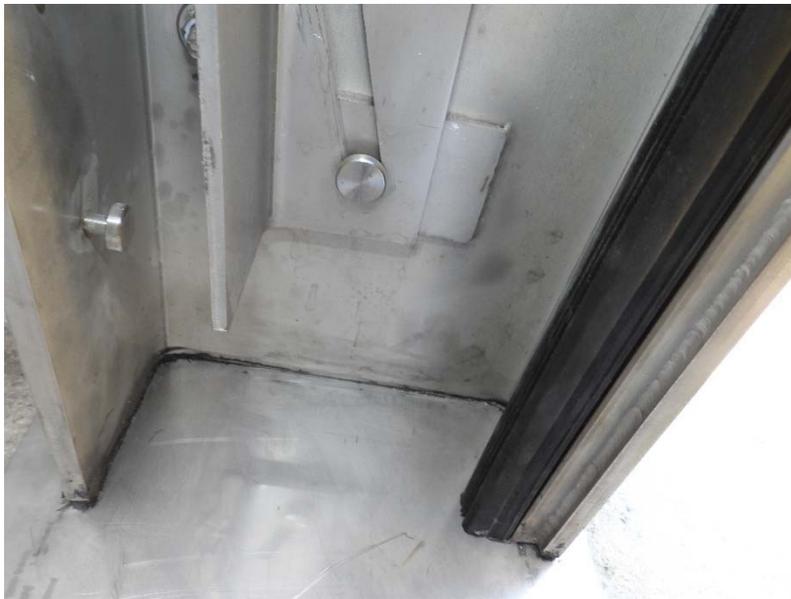
The lab testing chamber with a meticulously prepared and saddle and sealed end of vertical gasket. The following two photos explain the primary difference between the actual building.

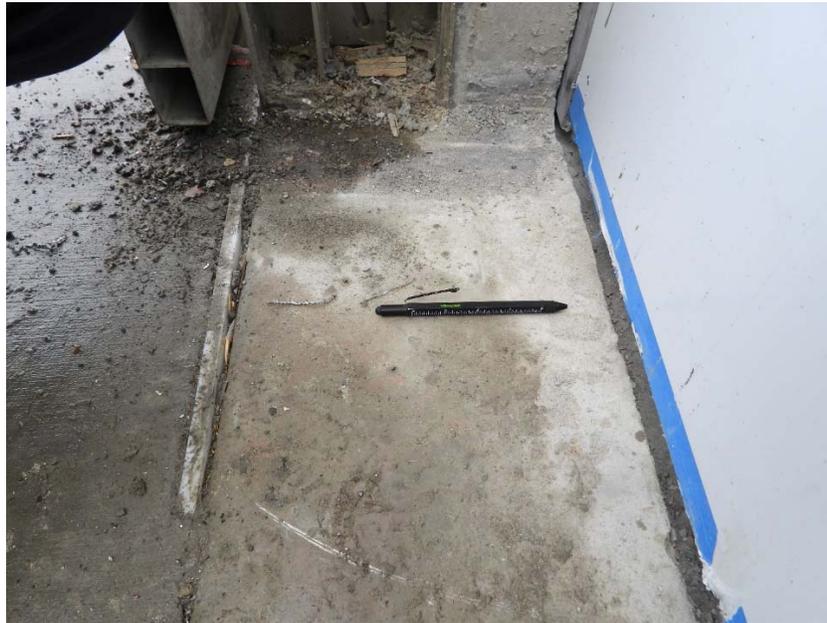
Actual Building: Flood Barrier Gasket Substrate Uneven: Caked With Concrete and Dirt, visible debris, missing vertical gasket.

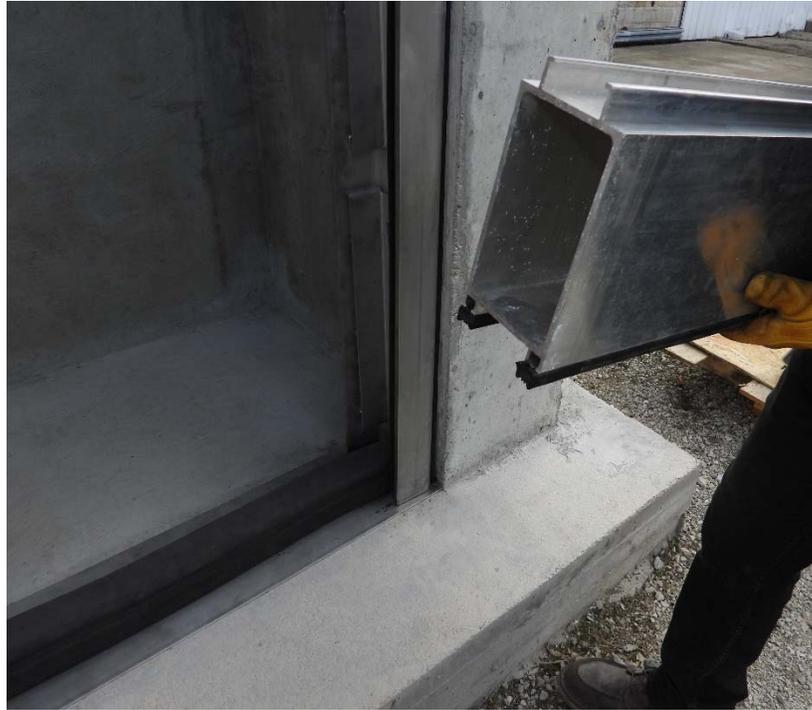
The lab testing chamber: installation of the first log. Visible additional foam gasket placed across the sill, not always provided in the actual building.

In these three intervals, water leakage rate dropped successively. The observed leakage chiefly took place between the first log and the saddle, and their corners were the largest contributors. Minor leakage was observed at horizontal and vertical gaskets above the first log. Leakage was allowed to run in the ground, and its volume was not measured. No extraneous leakage was observed from the chamber. First hour resulted in measured drop of 1'-6 1/4" corresponding to loss of 130 gallons, after second hour we measured drop of 1'-4 3/4" (113 gallons of water), and third 1'-2" (97 gal.), respectively.

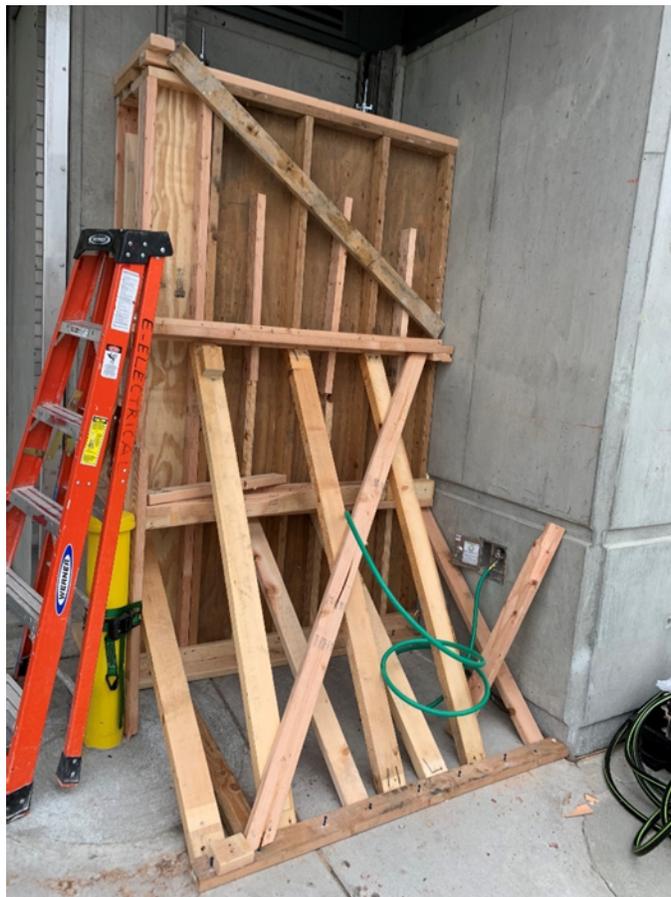
Field testing of similar assembly. Exterior view.

In our field testing, we erected an 8 ft tall wooden chamber lined with a waterproofing membrane and sealed at the edges, and then re-sealed it again when it proved to leak at the perimeter seal. Eventually the best we could achieve was the chamber leaks appeared negligible, and leaked significantly less voluminous than the flood barrier. The chamber was emptied, and then filled up to approximately 73% of the specified water head, water intake was stopped, and 12 minutes later, a 19-inch drop was observed, corresponding to a loss of approx. 97 gallons, and corresponding with leakage rate of 486 gph, with a significant fountain-like leakage observed through the flood barrier (e.g. a 12oz coffee cup held in front of the interior side of the chamber filled in 1.07 min, indicating 0.018 l/s leakage rate just at this single spot). The result of our testing needed to be extrapolated to the specified flood elevation, and yielded approx. 0.135 l/s/m, placing it in Class 2 of the DIN standard, which seems to be an average result in comparison with similar products sold on European market.

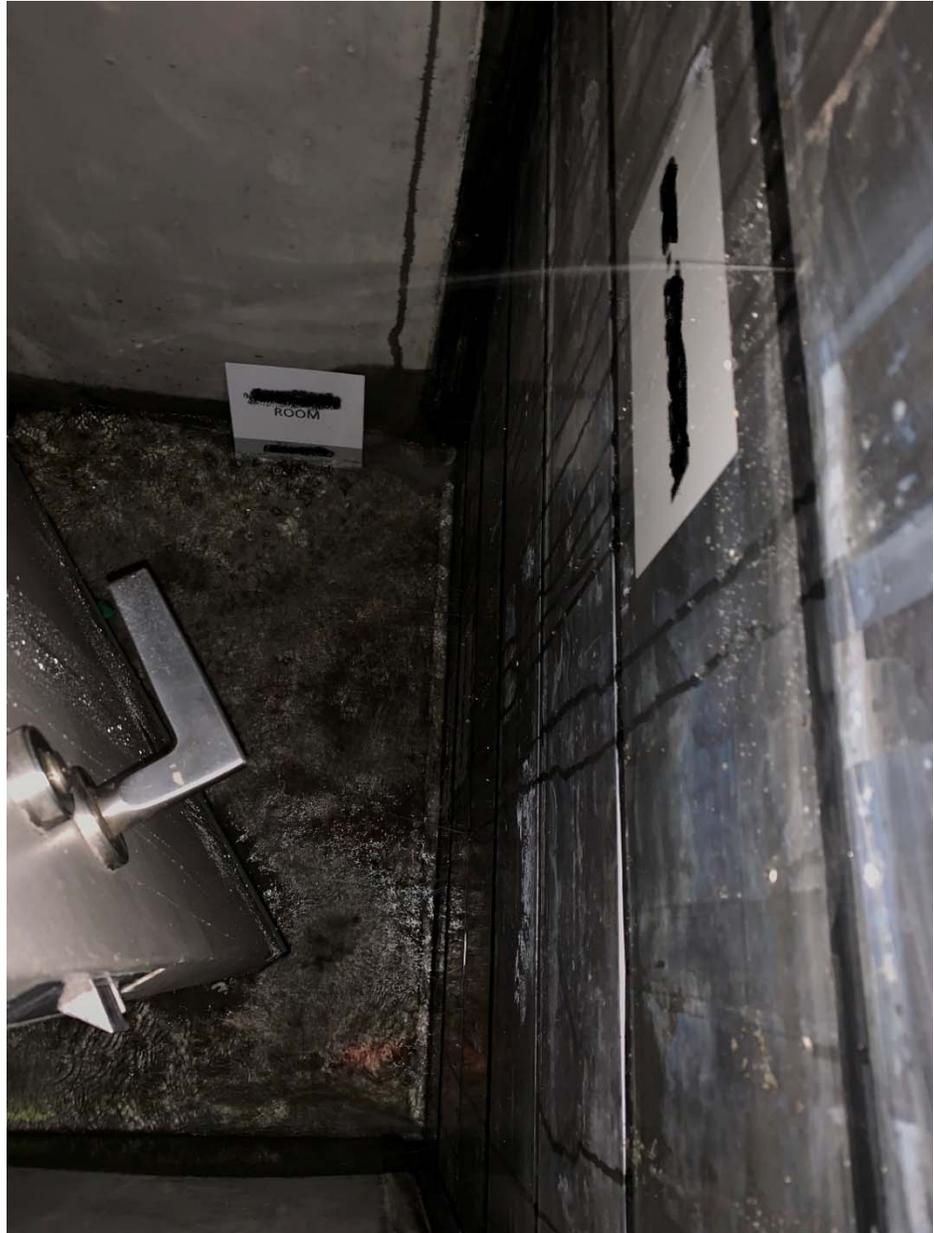
Field testing of log flood barrier in front of single pedestrian door. Water gushing out of the gaskets, and streaming out of the threshold area. Interior view. Visible insufficient space between the door and the flood barrier preventing opening the door for interior access to the barrier. Door and log labels were anonymized on the photo.

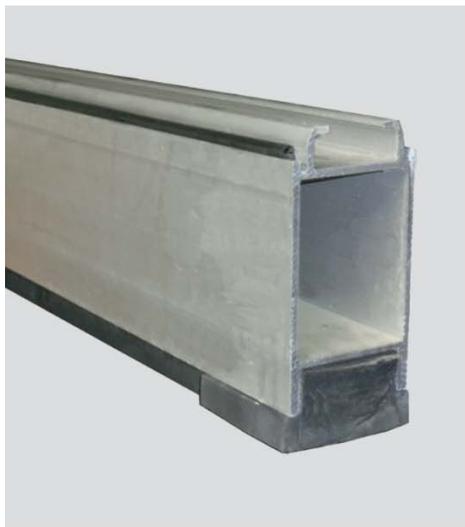
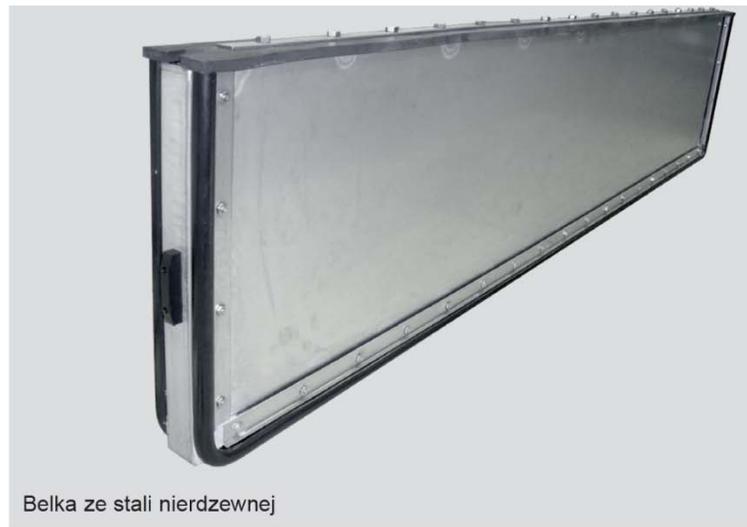
Details from Buesch, showing smart solutions for a corner seal of a log barrier.

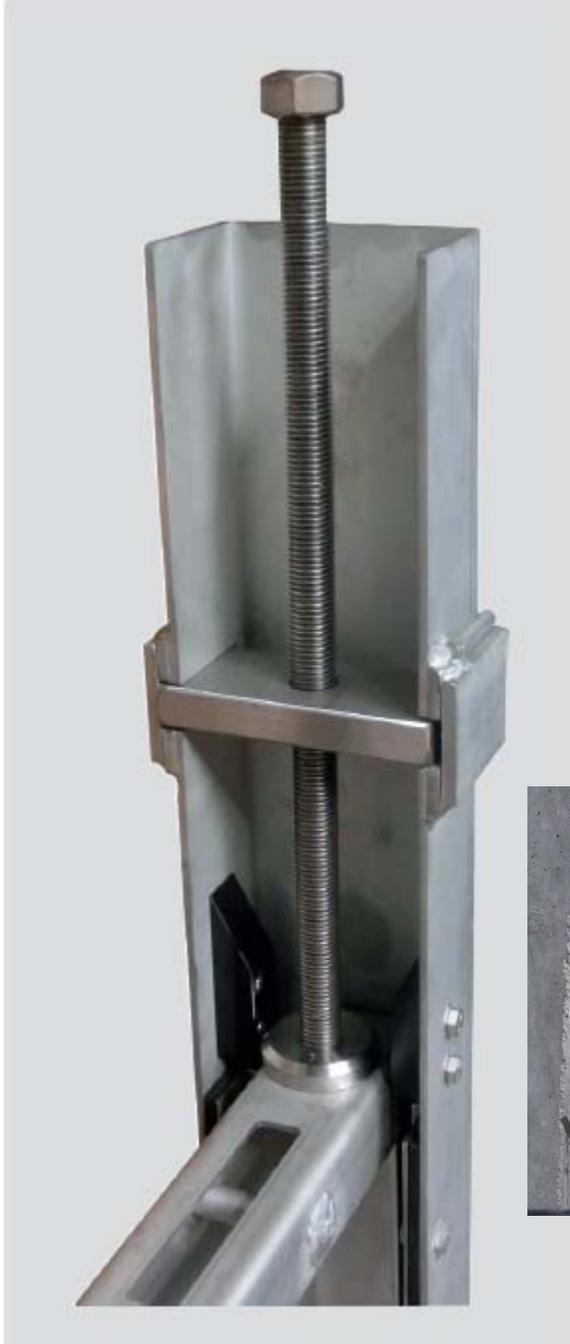
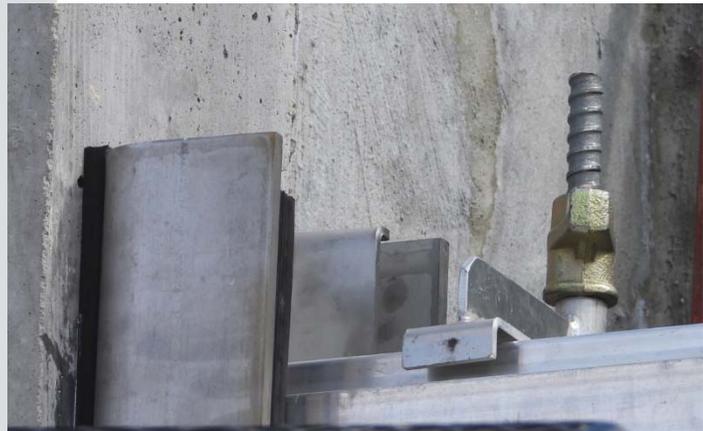
Detail from Buesch, showing a winch with a very dense thread. See earlier discussion about the winches, and the photo of a wide pitch thread combined with a small arm on the right side for comparison.

wider thread pitch, and short wrench's arm, with the unfortunate result of making it impossible to obtain a good gasket compression. Good gasket compression requires a tighter thread pitch and larger arm, and therefore some additional ad-hoc tools like arm extending rods, pipes, hammers, and levers were seen utilized in lab settings in preparation for testing and during the testing to help gaskets to settle in place, while the manuals were mute about them.

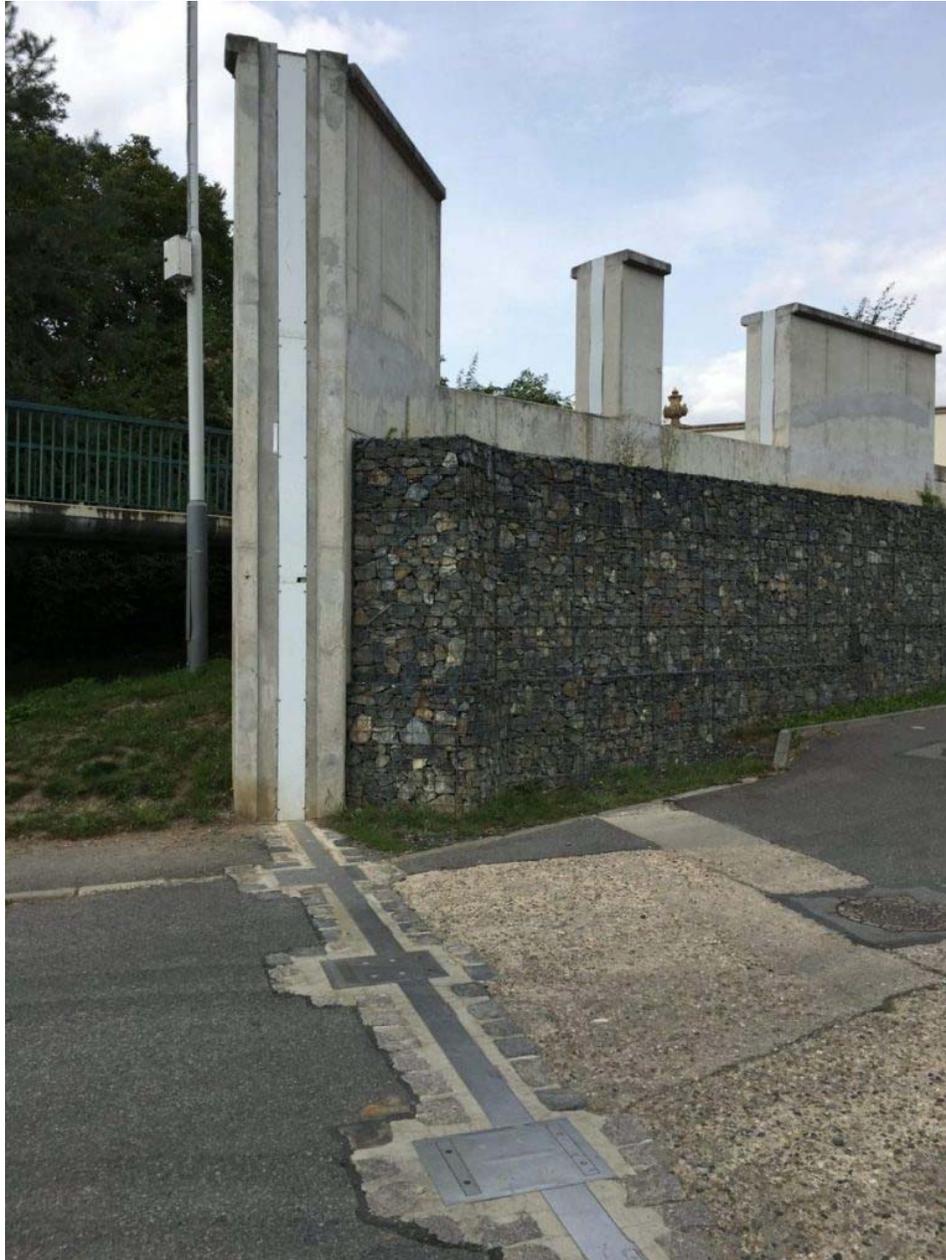
A flood gate jamb with a base receptor and post anchors. Could not find credits for this photo. If you recognize it, please let me know.

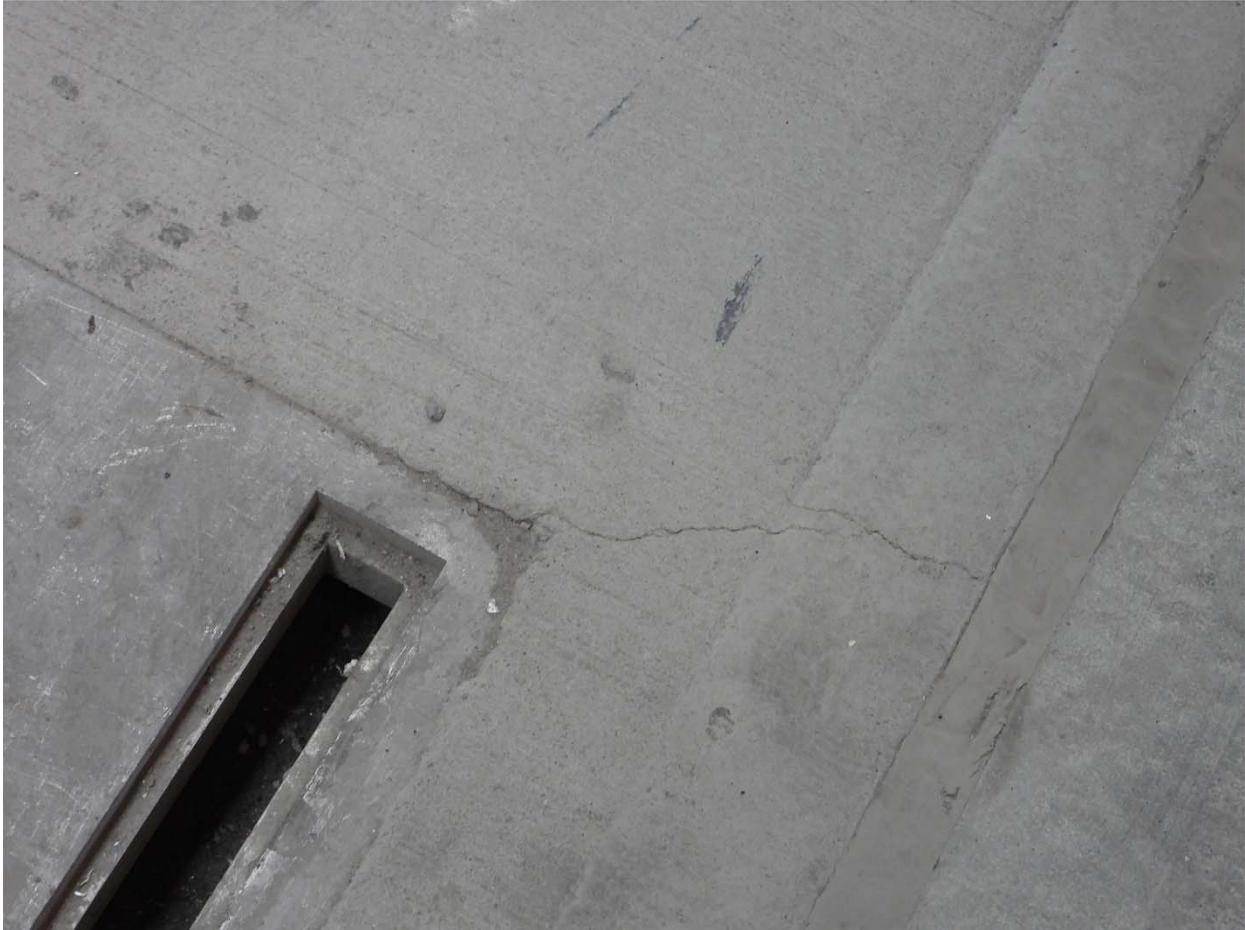
Visible variations and discontinuities in Floor Surfaces Interfacing the Bottom Seal of Flood Barriers: Perpendicular Control Joints and cracks. The entire sidewalk surface at this location is floating over a discontinuous waterproofing installation, so the flood barrier would be bypassed under the sidewalk.
